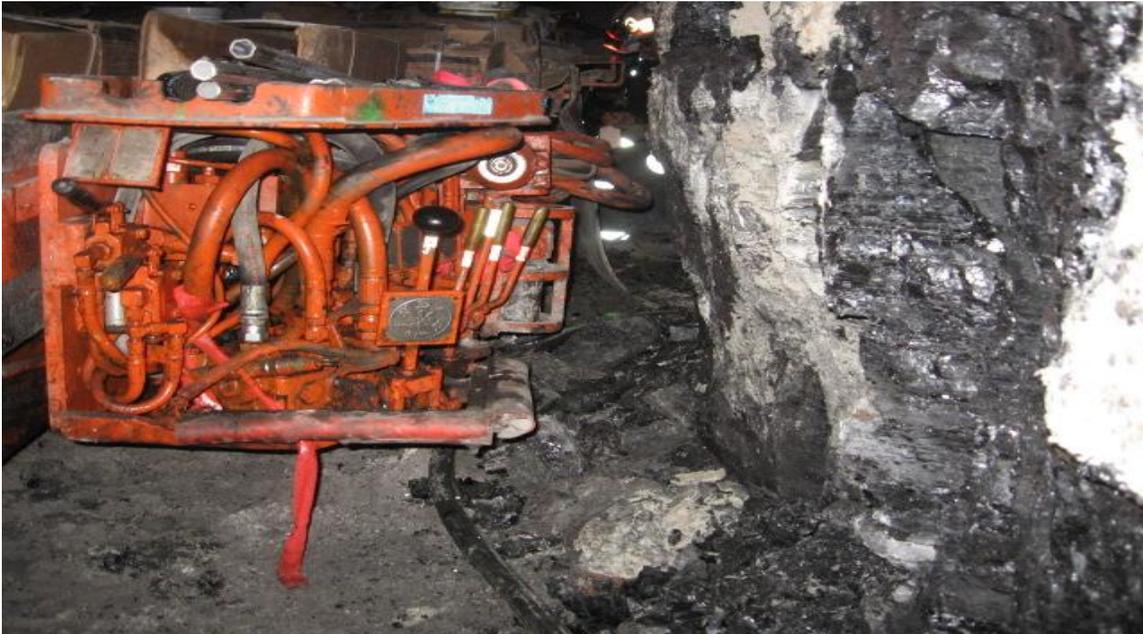
At approximately 7:50 A.M. on June 25, 2010, a serious personal injury occurred at an underground coal mine located in Wise County, VA. The victim was seriously injured when he became caught between the rib and the left drill boom of a Fletcher dual head roof bolter. The operator stepped into a “pinch point” area while the roofdrill was still in operation. The drill operator received a fracture to his left femur that required surgery to repair.

- No miner shall place himself or be placed in a pinch point between equipment and a rib or face.**
- Always perform Pre-Operational examinations of equipment before placing equipment into operation. Equipment issues/concerns should be reported immediately to your supervisor for necessary corrective action.
- Self propelled equipment shall be maintained in a safe operating condition.
- Always remain vigilant and be constantly aware of your surroundings.
